# “Tsawwassen Walkability Study”

## Tsawwassen: Intersections

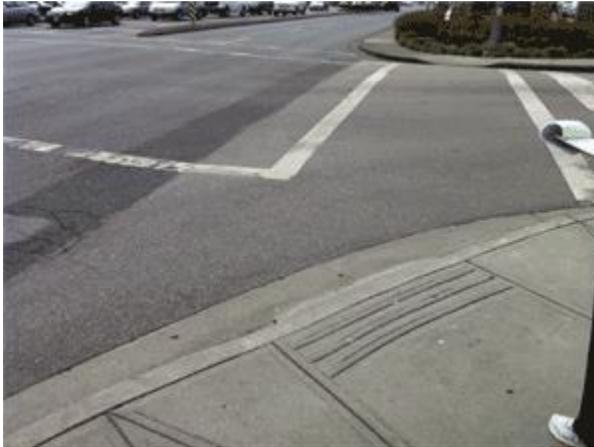
### 56th Street and Mall Access Road - Curb Access

**In the foreground the curb ramp is narrow and does not align with either crosswalk.**

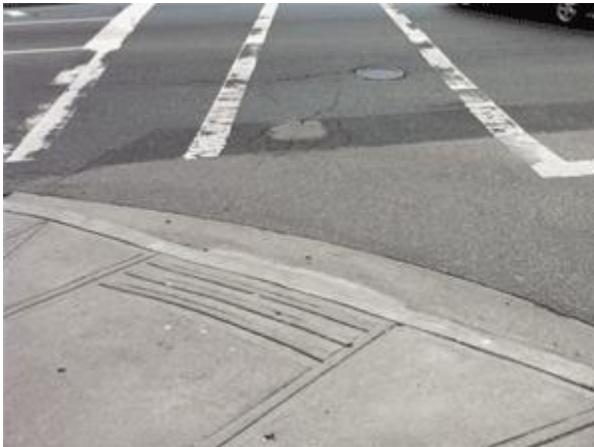
**In the background the curb ramp aligns with crossing the mall access road but not 56th. It was also noted that pedestrian crossing signal is out of sync with the audible signal. The signal starts at 22 seconds where it used to be 29. Twenty-two seconds was not enough time for our walkers with mobility issues.**

**This curb ramp is for use in both directions and is aligned toward the middle of the intersection. Proper alignment not only guides pedestrians into the crosswalk but also assists low vision pedestrian.**

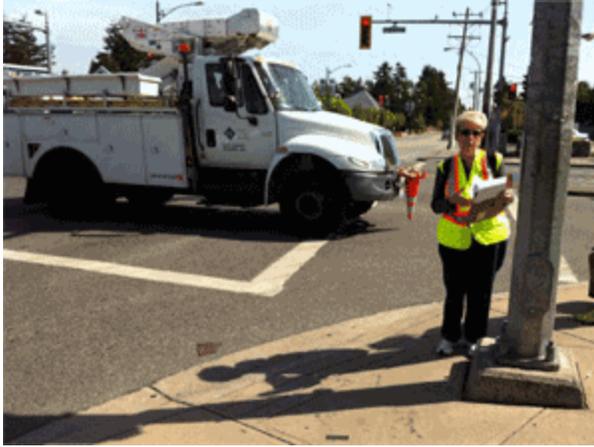
### 56th Street and 12th Avenue - Narrow

**The narrow sidewalk and barriers like this pole leave little area for waiting. A senior on a scooter would have difficulty manoeuvring in this small area. During our survey we saw a senior on scooter who had to go into the roadway get around pedestrians standing at the corner. Note that the curb ramp is aligned for 56th only and not 12th.**

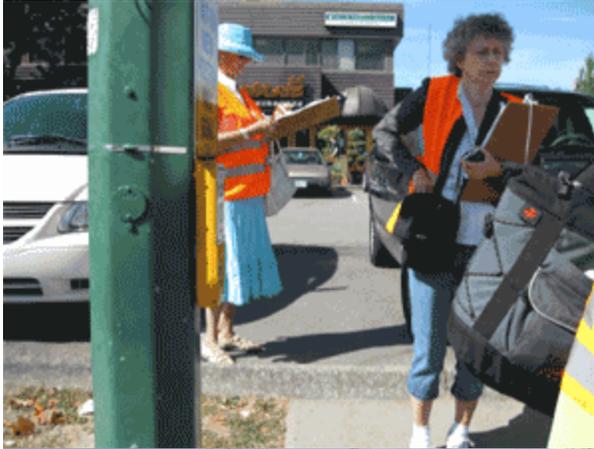
**Royal Oaks and 56th Street – Pedestrian controlled crossing**

**Crossing 56th at Royal Oaks pedestrians are faced with a dead end crosswalk. The choice is to step over the curb in the foreground of this picture. OR...**

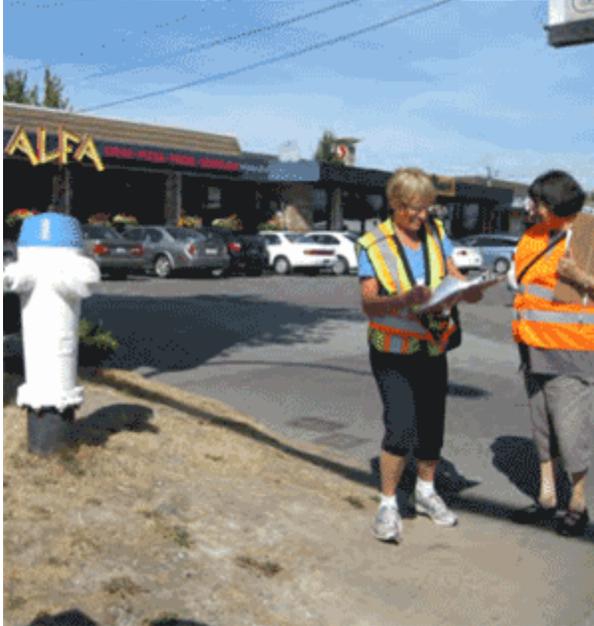
**Walk to the right and use the driveway entrance into the parking lot of the medical building.**

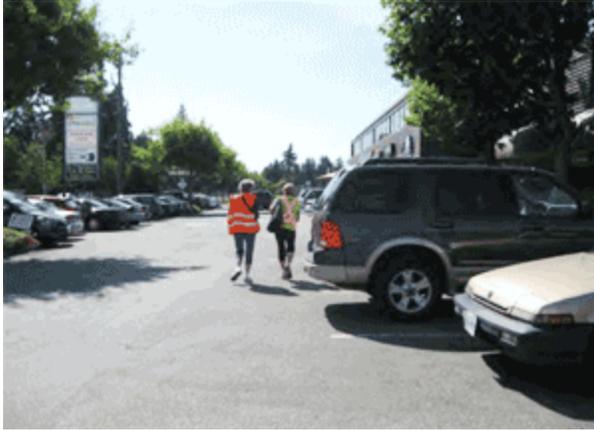
**With either choice pedestrians have to walk in the parking lot. Other problems noted at this intersection: the length time from pushing the button to activate the signal and the signal changing as well as difficulty hearing audible signal due to traffic noise.**

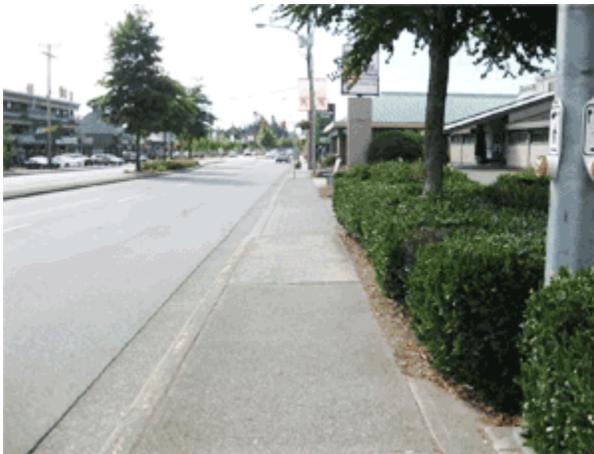
### **56th Street at View**

**Looking south, on the west side of 56th Street – sidewalk is narrow which does not allow for more than two people to walk together. Lack of a buffer between pedestrians and busy often speeding traffic creates an unsafe atmosphere.**

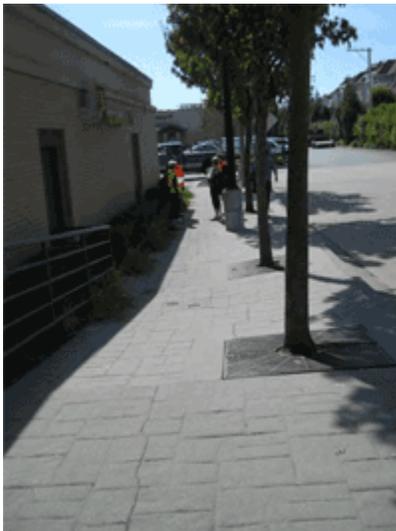
### **Exiting Bayside Mall up to 12th Avenue**

**This sidewalk is on a grade and the uneven slope downward from the roadway to the building is difficult to navigate.**

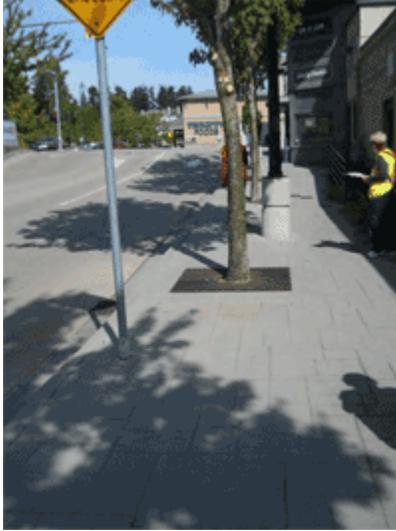
**Looking from the other direction, it shows the obstruction created by the trees. The combination of uphill grade, uneven, sloping sidewalk and obstructions make navigation more difficult for pedestrians. This sidewalk is a connection to the mid block pedestrian crossing to the grocery store on the north side of 56th Street.**

**We were informed by a senior walking along this route that the brick surface that is illustrated may be unsuitable for seniors. The example we were given is that for seniors with arthritis, they may have to use a walker with arm rests to support themselves. The vibration and jolting caused by the brick surface may cause irritation and pain for the senior.**

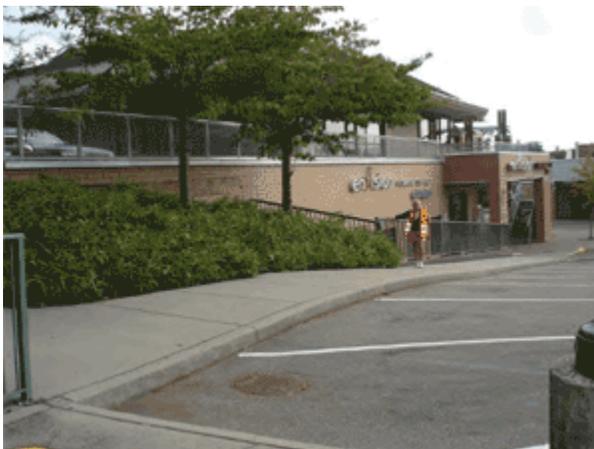
### **Sidewalk on a grade by Tsawwassen Library**

**Sidewalk up to library has a railing for part of the way but ends where the landscaping begins. The sidewalk is on a steep grade and a railing to the top may provide additional assistance pedestrians who need support.**

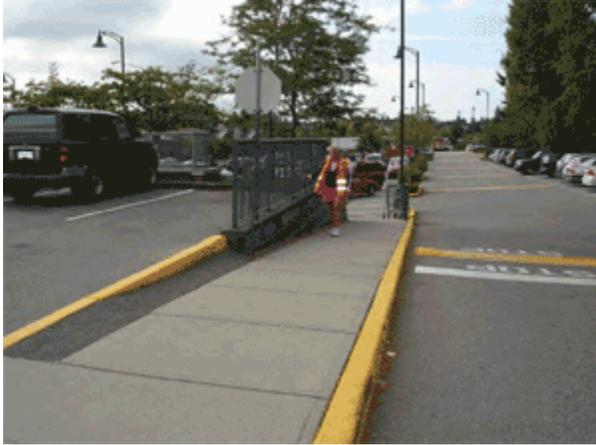
**Continuing around the corner from the picture above the railing ends again before reaching grade.**

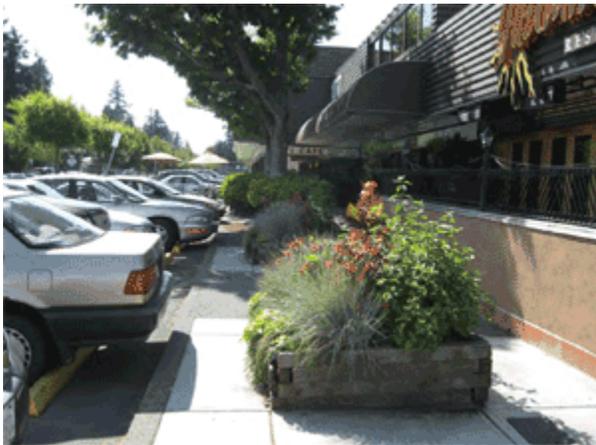
### **Sidewalk Obstructions**

**Planters on walkway are pleasant to look at but they could be an obstacle for pedestrians using walking and mobility aids. The place of the planters also does not allow for pedestrians to walk side by side Informal pathways.**

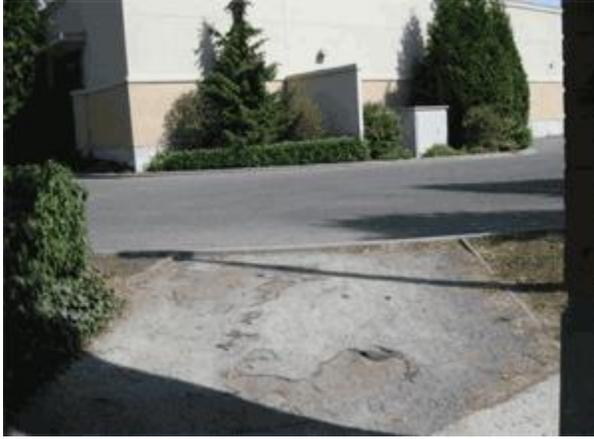
**This pathway shows the wear and tear of a cut through used by pedestrians to access Bayside mall or the service road up to 12th Avenue near 56th Street.**

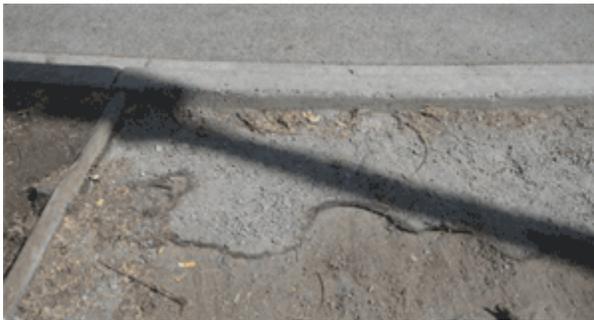
**Notice now the surface of the pathway has sunk and created a lip. A senior using a walker was observed negotiating this hazard. She waited until someone came along who could lift her walker over the lip and down on to the roadway.**

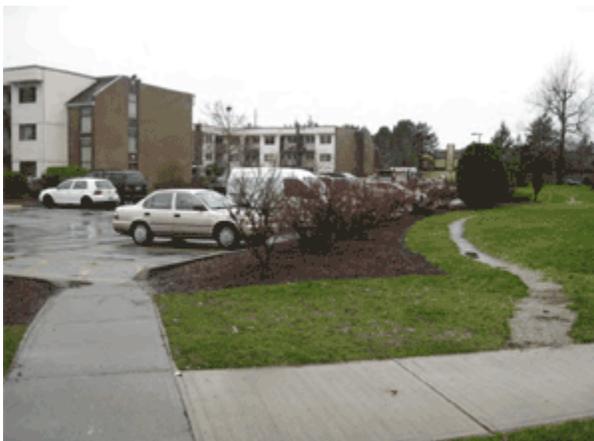
**The pathway connects to apartments where many seniors live. To get to this point there is a choice to walk through a parking lot or use a narrow pathway.**

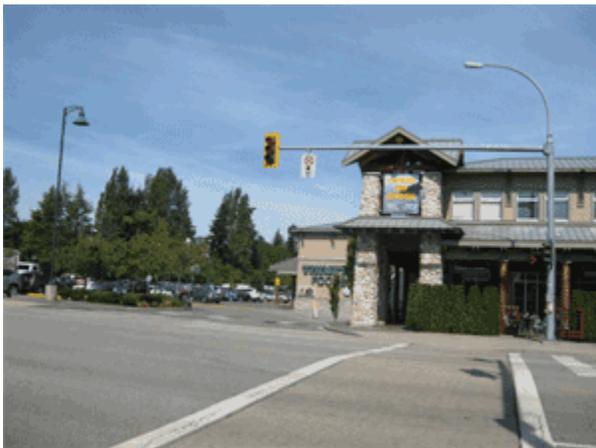
**12th Avenue between 56th and 55th Streets - crossing**

**The sign by the traffic light does not permit vehicles to turn right on red lights. That means at all times when pedestrians are using this cross walk, cars must wait until pedestrians have crossed, leaving little time for making a right turn. While waiting to cross we observed cars turning right on the red light. It was also reported to us that when traffic is heavy, driver attention is more on getting out into traffic then it is on the pedestrians crossing. We observed that the timing of the pedestrian signal is short for seniors who walk a little slower.**

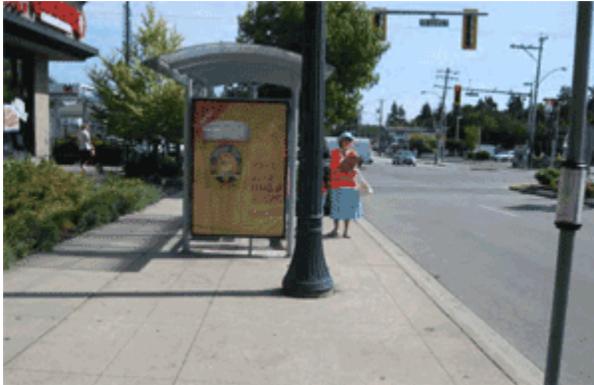
**In the same half block, a bus stop is located near a busy intersection. When the bus is loading cars change lanes, drivers are distracted and the 4 lanes of traffic are a challenge for pedestrians with mobility issues. It was noted that the pedestrian signals at 56th are not long enough for pedestrians using walkers/canes.**

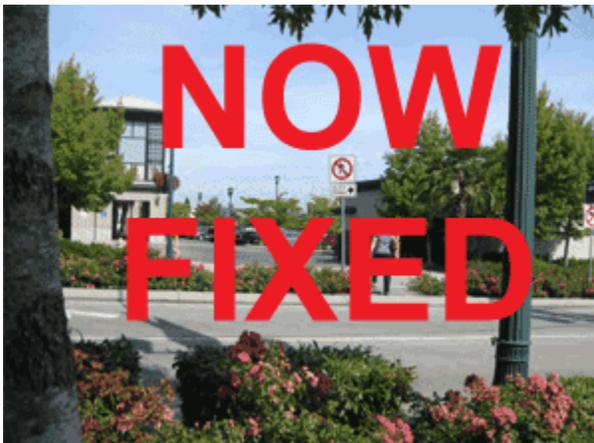
**Between the mid block crossing on 12th Avenue and the intersection at 56th, across from the bus stop jaywalking occurs despite signage – pedestrians are looking for places to cross.**

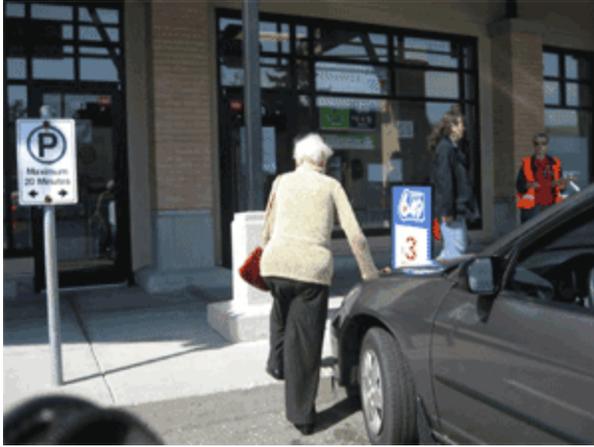
**Height of Curbs – not always standardized on business properties**

**This senior needs to lean on her car to get up this very high curb. Maintaining balance is very important for avoiding falls. Falling has serious consequences for seniors. Once a senior experiences a fall it will often discourage them from going out in future.**

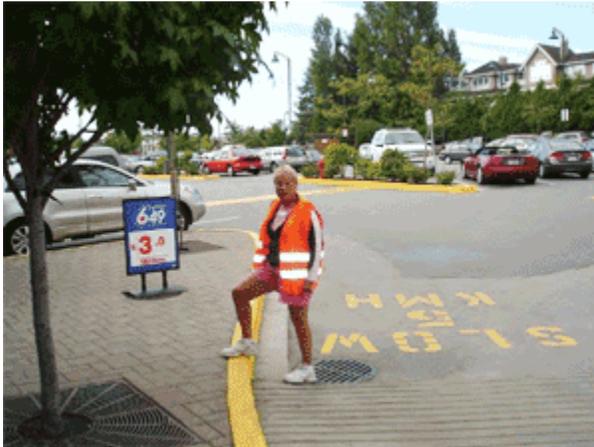
**In this picture the height of the curb is marked with yellow paint to warn pedestrians but illustrates the height of a person's step needed to navigate a high curb.**

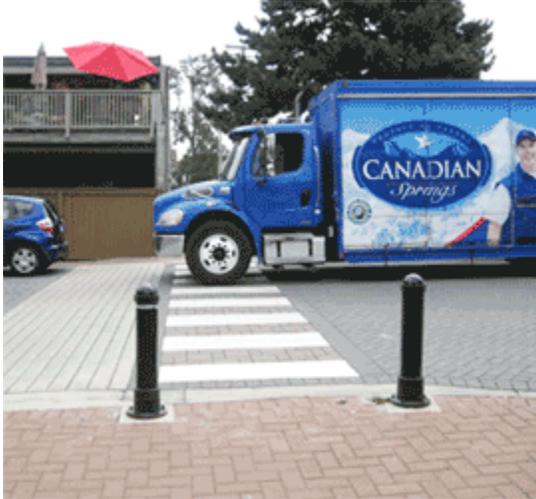
**Pavers and bricks are attractive and commonly used for walking surfaces but there is potential for tripping hazards when they become dislodged. We learned on our walk that there are new materials available that can be added to the sand to prevent heaving.**

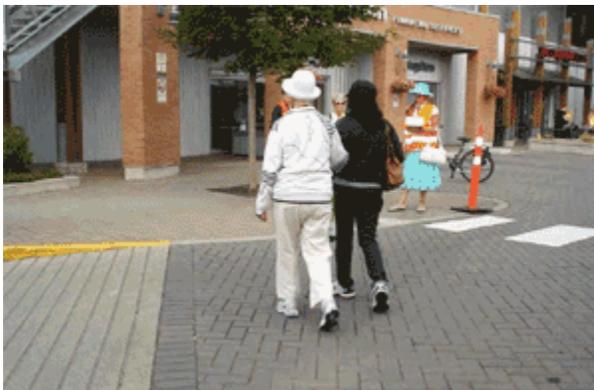
**But pedestrians do not always use the paths that are made for them.**

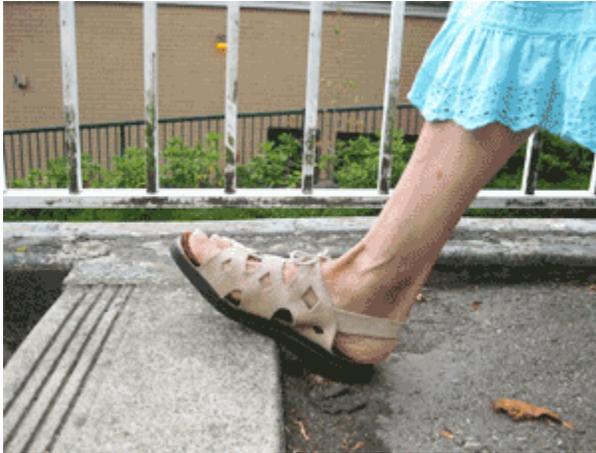
## **Example of Aging Infrastructure**

**This is an example of aging infrastructure - a pathway of asphalt ends at the top of a flight of concrete stairs. The asphalt has sunk and has created a tripping hazard. What is not shown in this photo is the location. The pathway is at the base of an incline which could pose a further hazard for seniors due to loss of balance.**

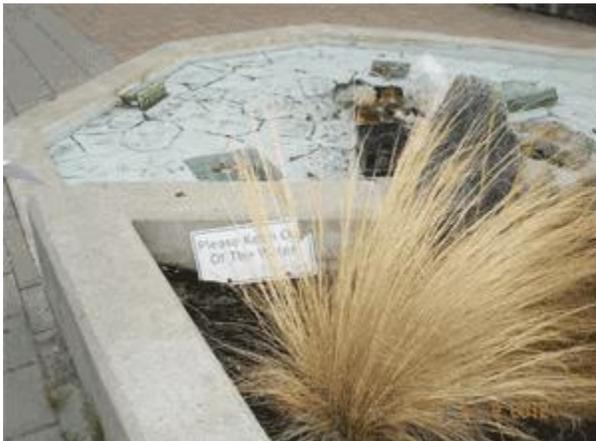
**The water garden is a pleasant feature and benches are provided for resting. However for low vision pedestrians the lack of a defined border or fencing could make this a hazard.**
