Ladner: Intersections

52A Street at Ladner Trunk

Ladner: Sidewalks

Ladner Delta: Safety

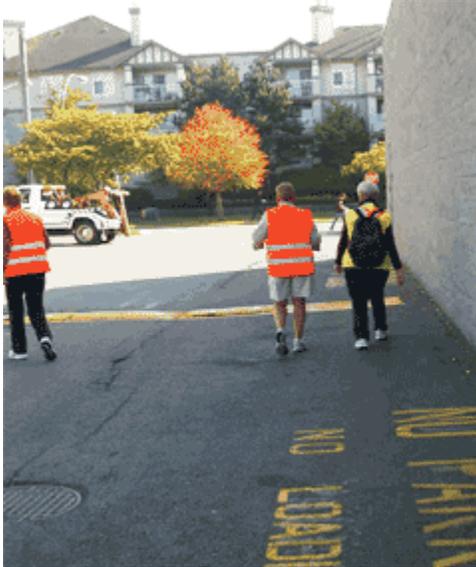
To walk from Ladner Centre Mall to Trenant Square Shopping Centre, using this intersection, pedestrians exit Ladner Centre Mall using the parking lot driveway. It was noted that to exit through the parking lot to Ladner Trunk involves passing a gas station that is so close to the sidewalk that drivers exiting their cars step on to the sidewalk.

At the time of our survey the pedestrian crossing time at this intersection was not long enough for slower walkers. A few weeks later one of our walkers reported the timing was increased and it is much easier to cross.

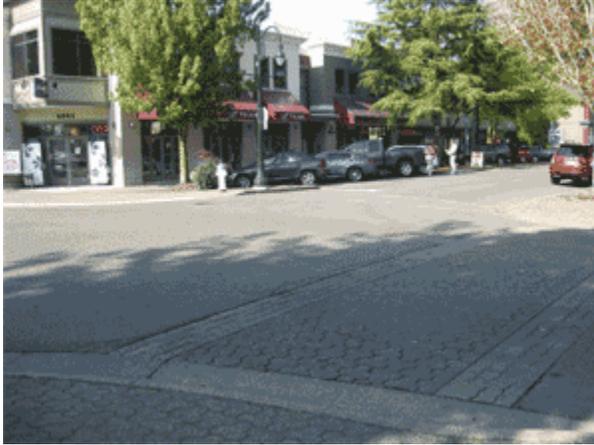
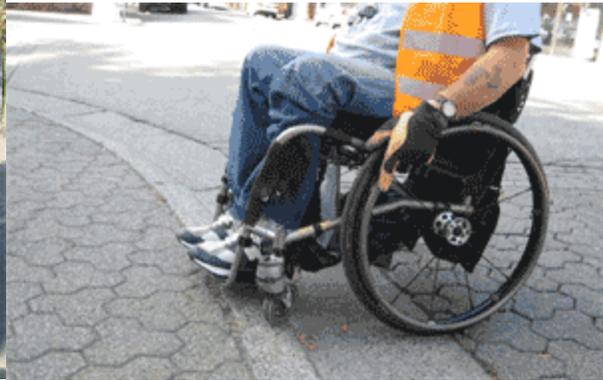
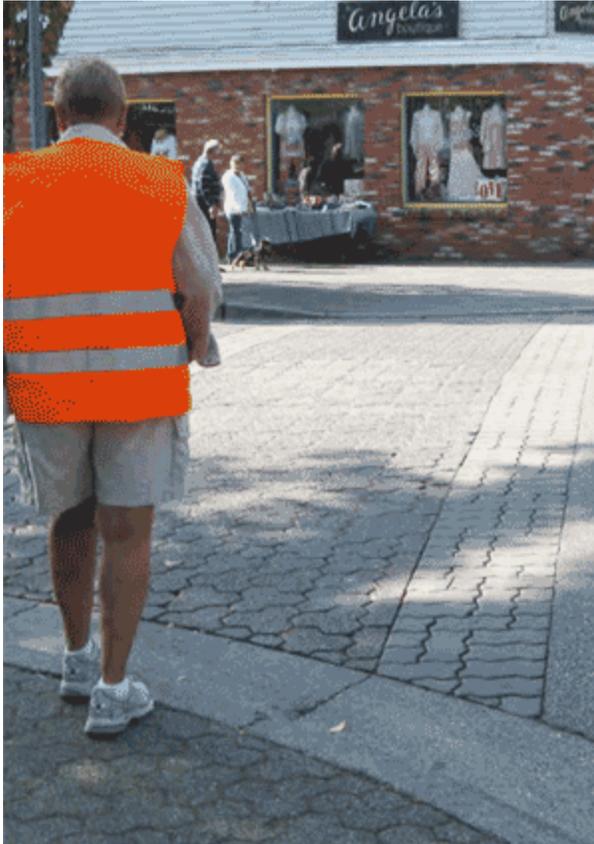
Bridge Street and Delta Street – in Ladner Village

This intersection provides examples of what works and what does not work. The northwest corner (directly ahead in photo) is an example a wide curb ramp that is level to the street, accommodating wheelchairs, scooters, walkers and pedestrians.

The curb ramp in the foreground (southeast corner) has what is called a soft or rolling curb. This type of curb is a particular hazard to a person in a wheelchair who has a high level paralysis (above waist). The jolt possible from this curb can cause injury.

The southwest corner (in background) has a wide curb ramp but there is a lip from the curb ramp to the street grade.

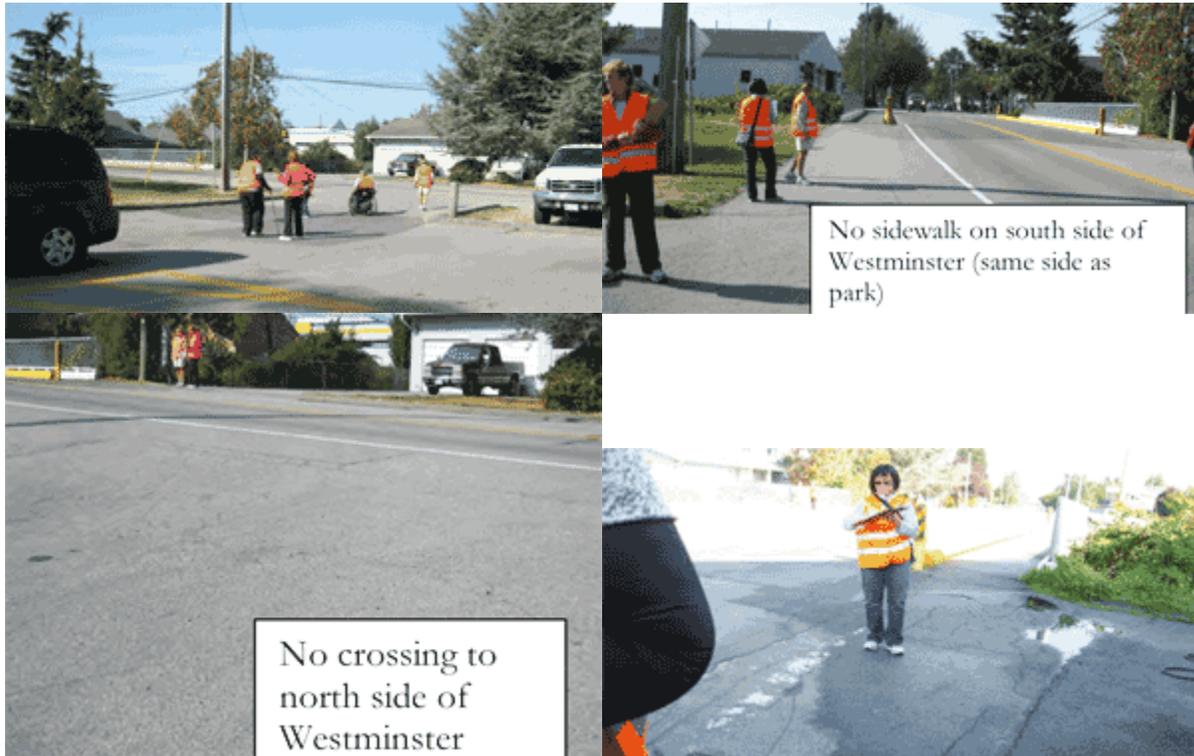
Leaving Lions Park to connect with Village– sidewalks are not continuous along Westminster Avenue to Elliott.

The first picture shows leaving the park through the parking lot.

The last picture in this group shows the sidewalk interrupted by a broken drive way between the Bridge and the intersection of Westminster and Elliot.

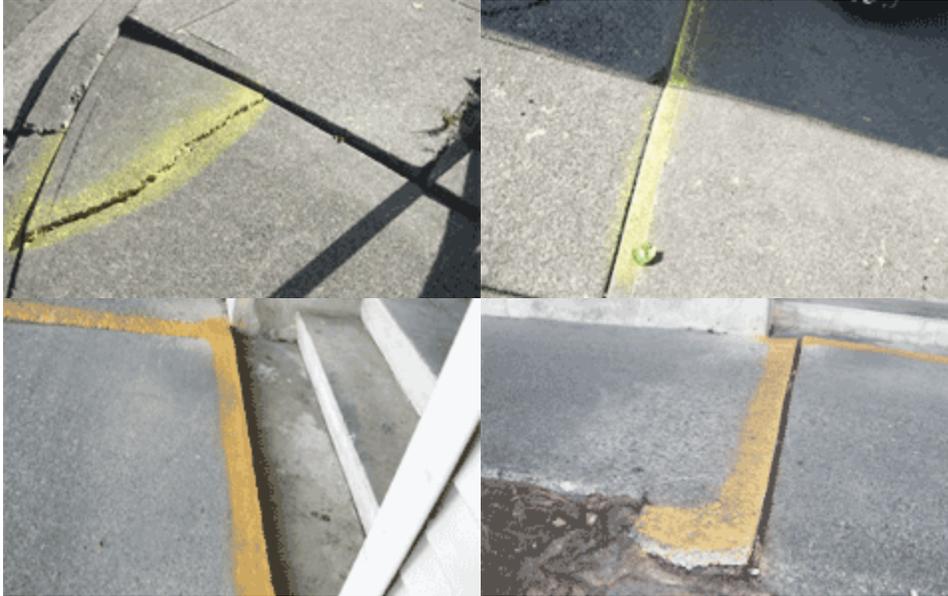
Narrow Aging Sidewalks in Ladner Village

Pictures of barriers to walkability in Ladner Village. The first two pictures are of cracks in the south side of Bridge Street, west of Elliot. Sidewalk and entrance to building not at same grade on Bridge Street. In fourth picture see how a tree root lifts the sidewalk and expands the sidewalk crack.

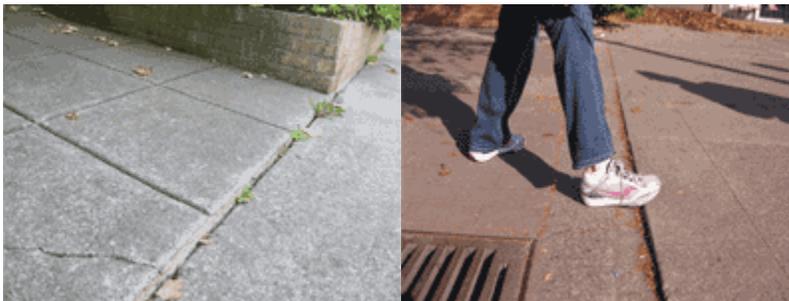
See two other issues: a tripping hazard created where grade of sidewalk and private property are not aligned and two different types of surface treatments can result in tripping hazard over time.

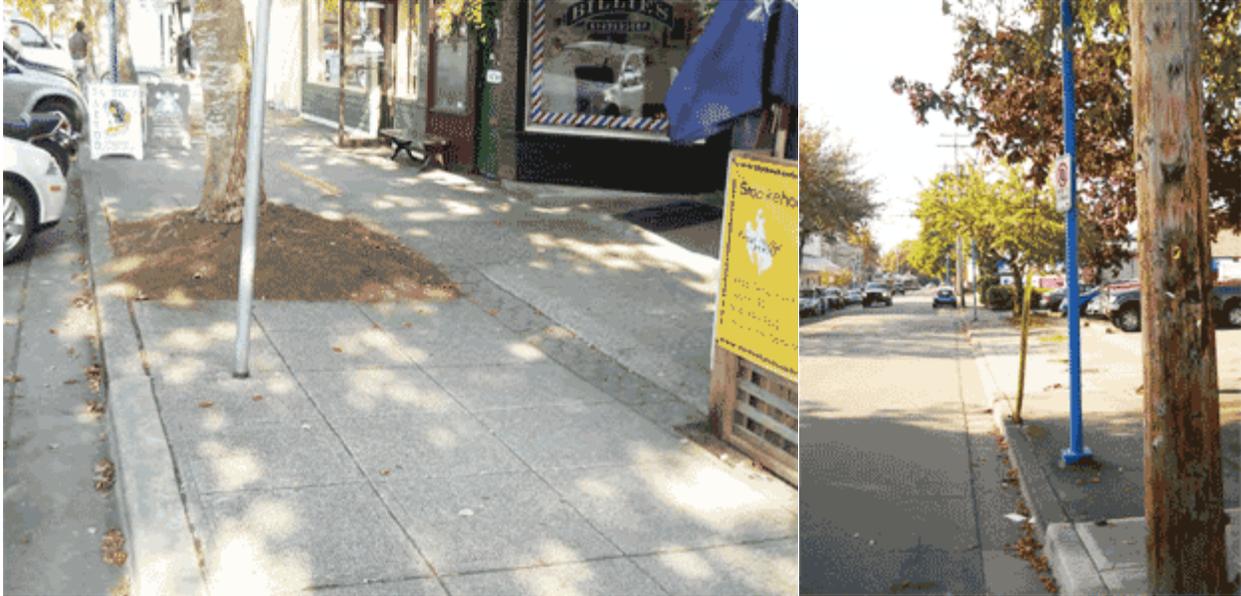
Narrow sidewalks with obstructions

Narrow and sidewalks filled with obstructions in Ladner Village community centre'

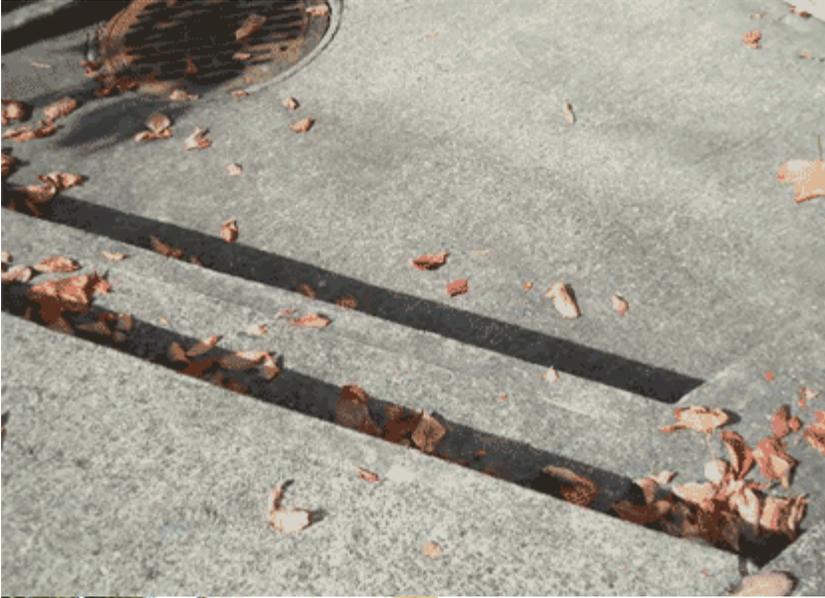
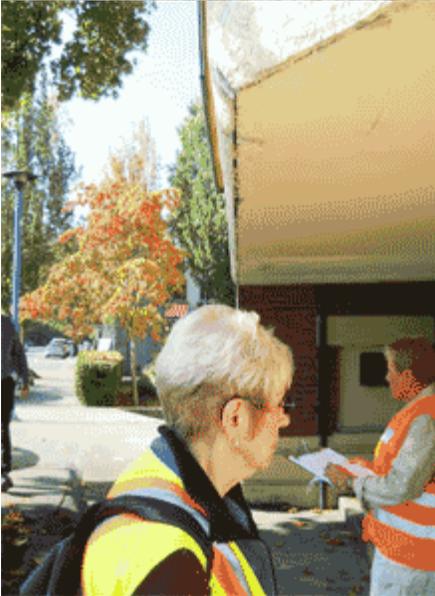
Two other challenges for Ladner Village Centre are: at the Delta Museum our walkers are short but the corner of the building creates an overhang situation that could be a hazard to taller people and these low rise stairs are not marked and would be difficult for a person with low vision to see. A line of paint on the edge of the step would help for visibility.

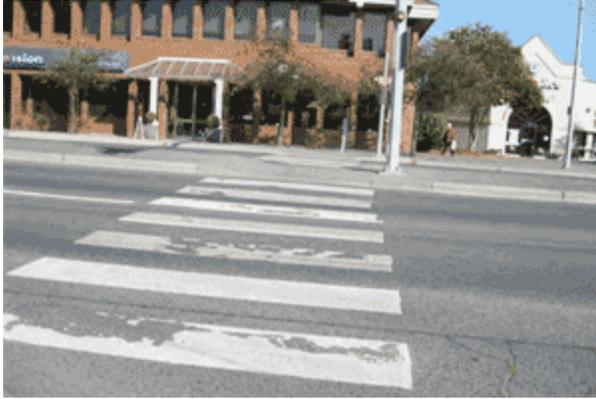
Midblock crossing – Ladner Trunk, east of Arthur drive, an example of crossing where pedestrians may not feel safe

Crosses 5 lanes of traffic, including right turn into Ladner Centre Mall, the small amber light on the post on the median is the only information pedestrians have as they cross.

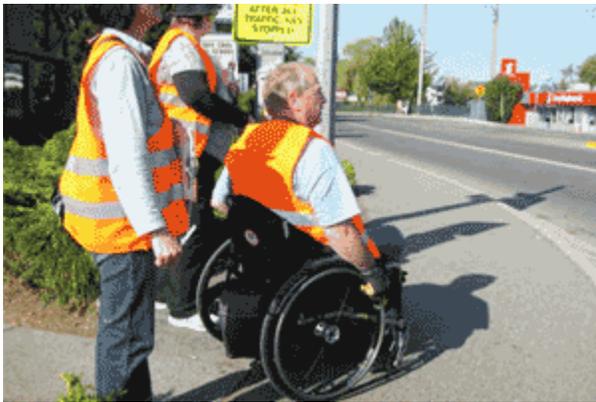
Note the sign says cross when all traffic has stopped. At this crossing, cars start moving once pedestrian passes them and cars on the far side may not stop until they see pedestrians in the crosswalk.

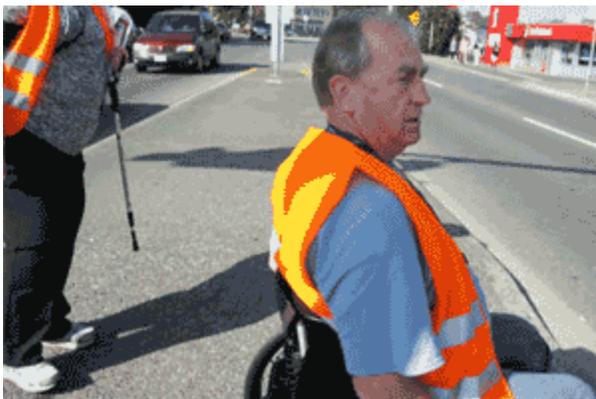
On the median, pedestrians hesitating, are the amber flashers above, facing the cars still flashing? The cars behind have started to move.

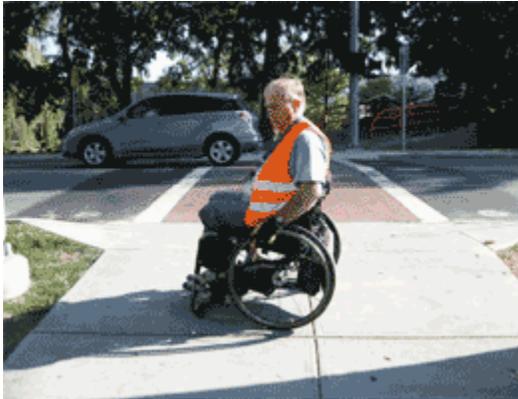
**Arthur Drive – midblock crossing between Ladner Trunk and 47th Avenue
Example of a pedestrian crossing where seniors feel safe**

Pedestrian crossing with easily accessible push button control and audible signal.

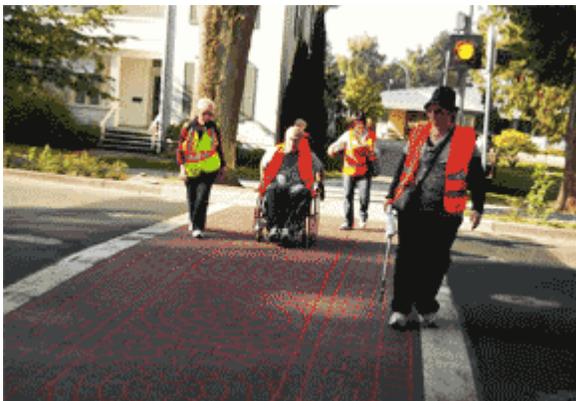
Yellow signal light is visible to pedestrians and the lights embedded in the roadway give an added sense of safety.

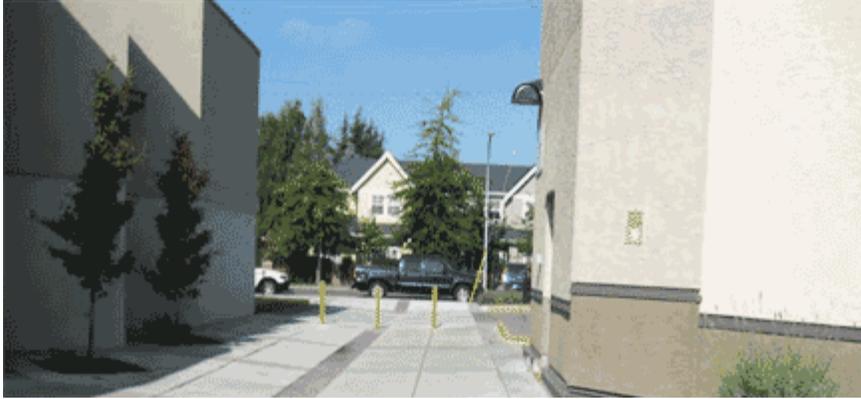
Mid block crossing – Central Ave between Trent Park Square Shopping Centre and Lions Park

With improvements, using Lions Park could provide a safe connection between the shopping mall and Ladner village.

Central Avenue at Trenant Park Square has reduced visibility due to parked cars and curve in road. Last picture shows no pedestrian crossing to Lions Park in background.

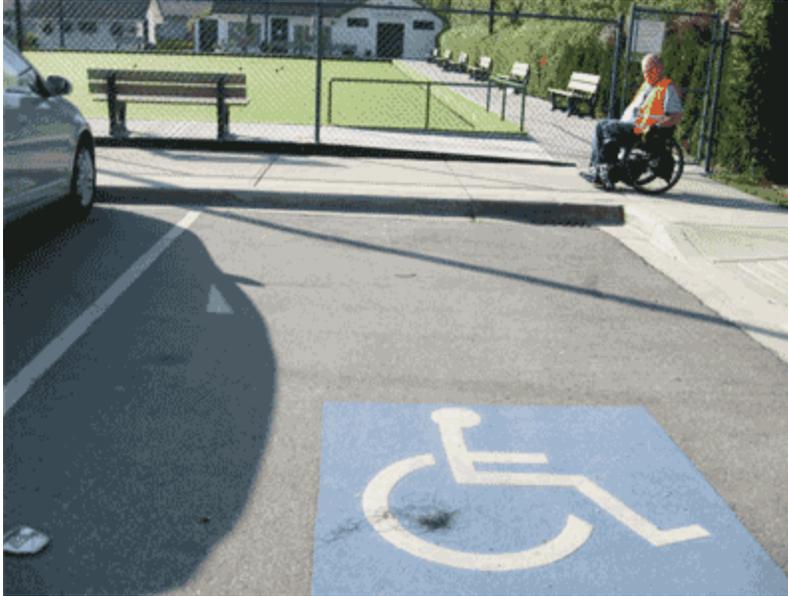
Use of handicapped parking places

The picture is a familiar parking space that is reserved for those with a parking permit to use handicap parking. The parking space is near the destination. It is also has the width to accommodate the unloading of a wheel chair or scooter. The ramp on the sidewalk to the right slopes to the road grade easing the access to the sidewalk.
