# “Tsawwassen Walkability Study”

## Tsawwassen: Intersections

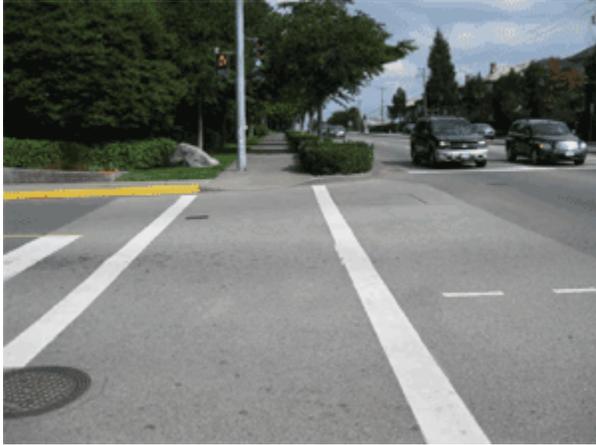
**In contrast looking north, the sidewalk is wider and has a landscaped buffer that separates pedestrians from traffic which makes a more comfortable walking environment.**

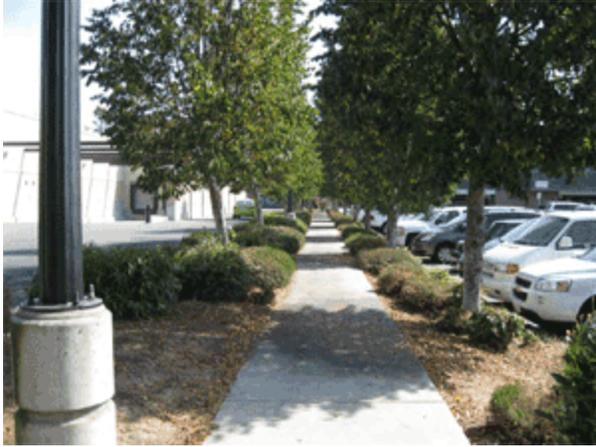
**The alternative for seniors is a less direct walkway using sidewalks on 10th Ave or down this long sidewalk.**

**Fatigue is a “hidden” problem experienced by seniors because others do not see it. Direct routes are important for conserving energy when fatigue is a concern and connecting pedestrians to places they need to go is important for supporting seniors in maintaining their independence.**

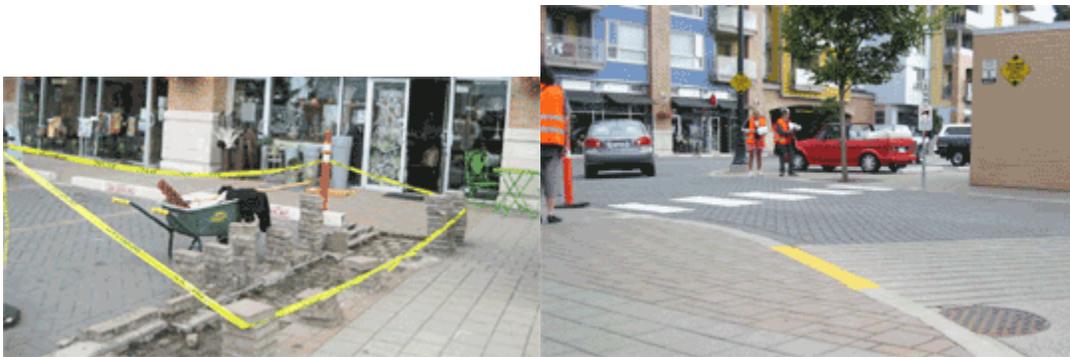
**Efforts to guide pedestrians through parking areas: the pedestrian crossing is marked with wide white stripe and a warning sign. Yellow paint on the curb marks the grade of the slope of the roadway (warning of a tripping hazard).**

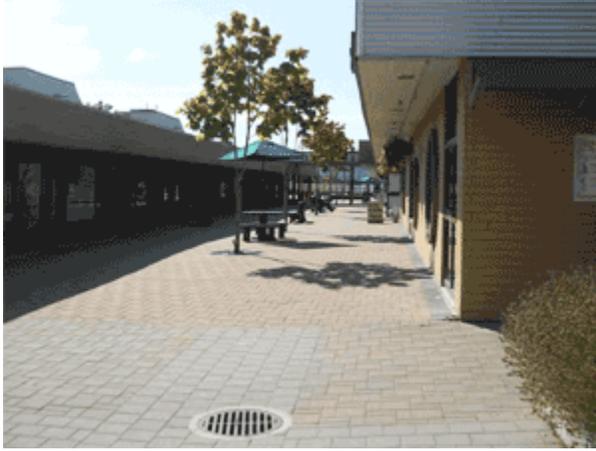
**Benches for resting and trees and umbrellas for shade add to the appeal for walking spaces.**

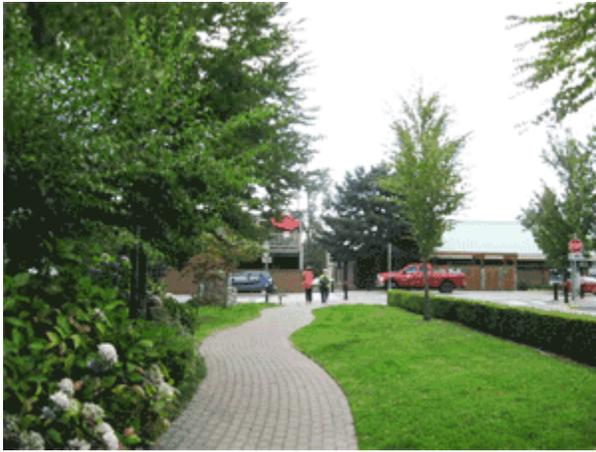
**An example of a walkway with a wide surface and landscaped buffer to separate pedestrians from traffic.**
